NASA Technical Memorandum TM 107554

Debris/Ice/TPS Assessment And Integrated Photographic Analysis For Shuttle Mission STS-52

December 1992

Gregory N. Katnik
NASA/Kennedy Space Center

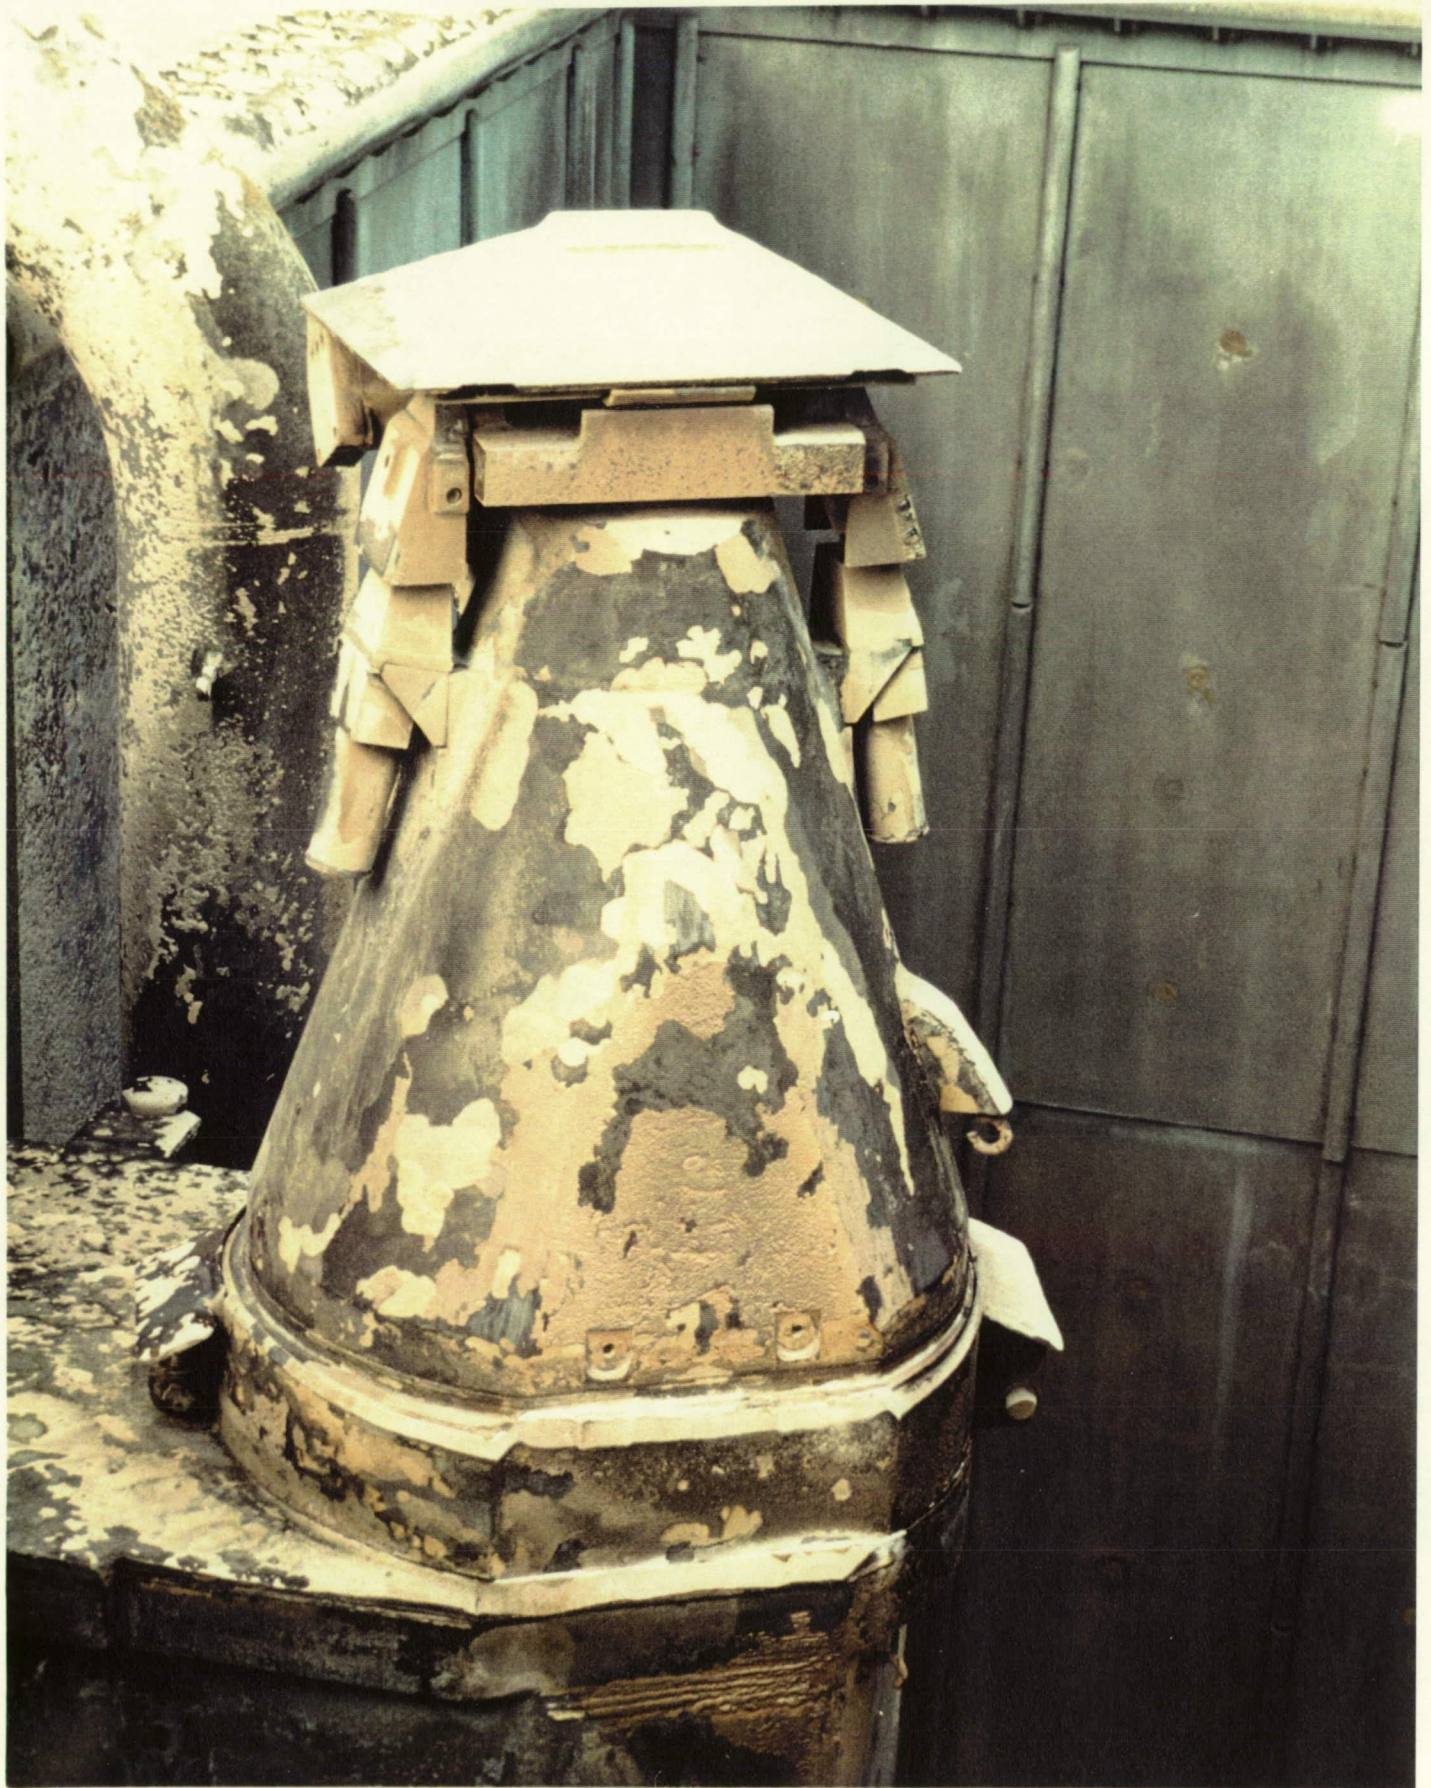
All of the north holddown post doghouse blast covers were in the closed position and showed typical plume erosion

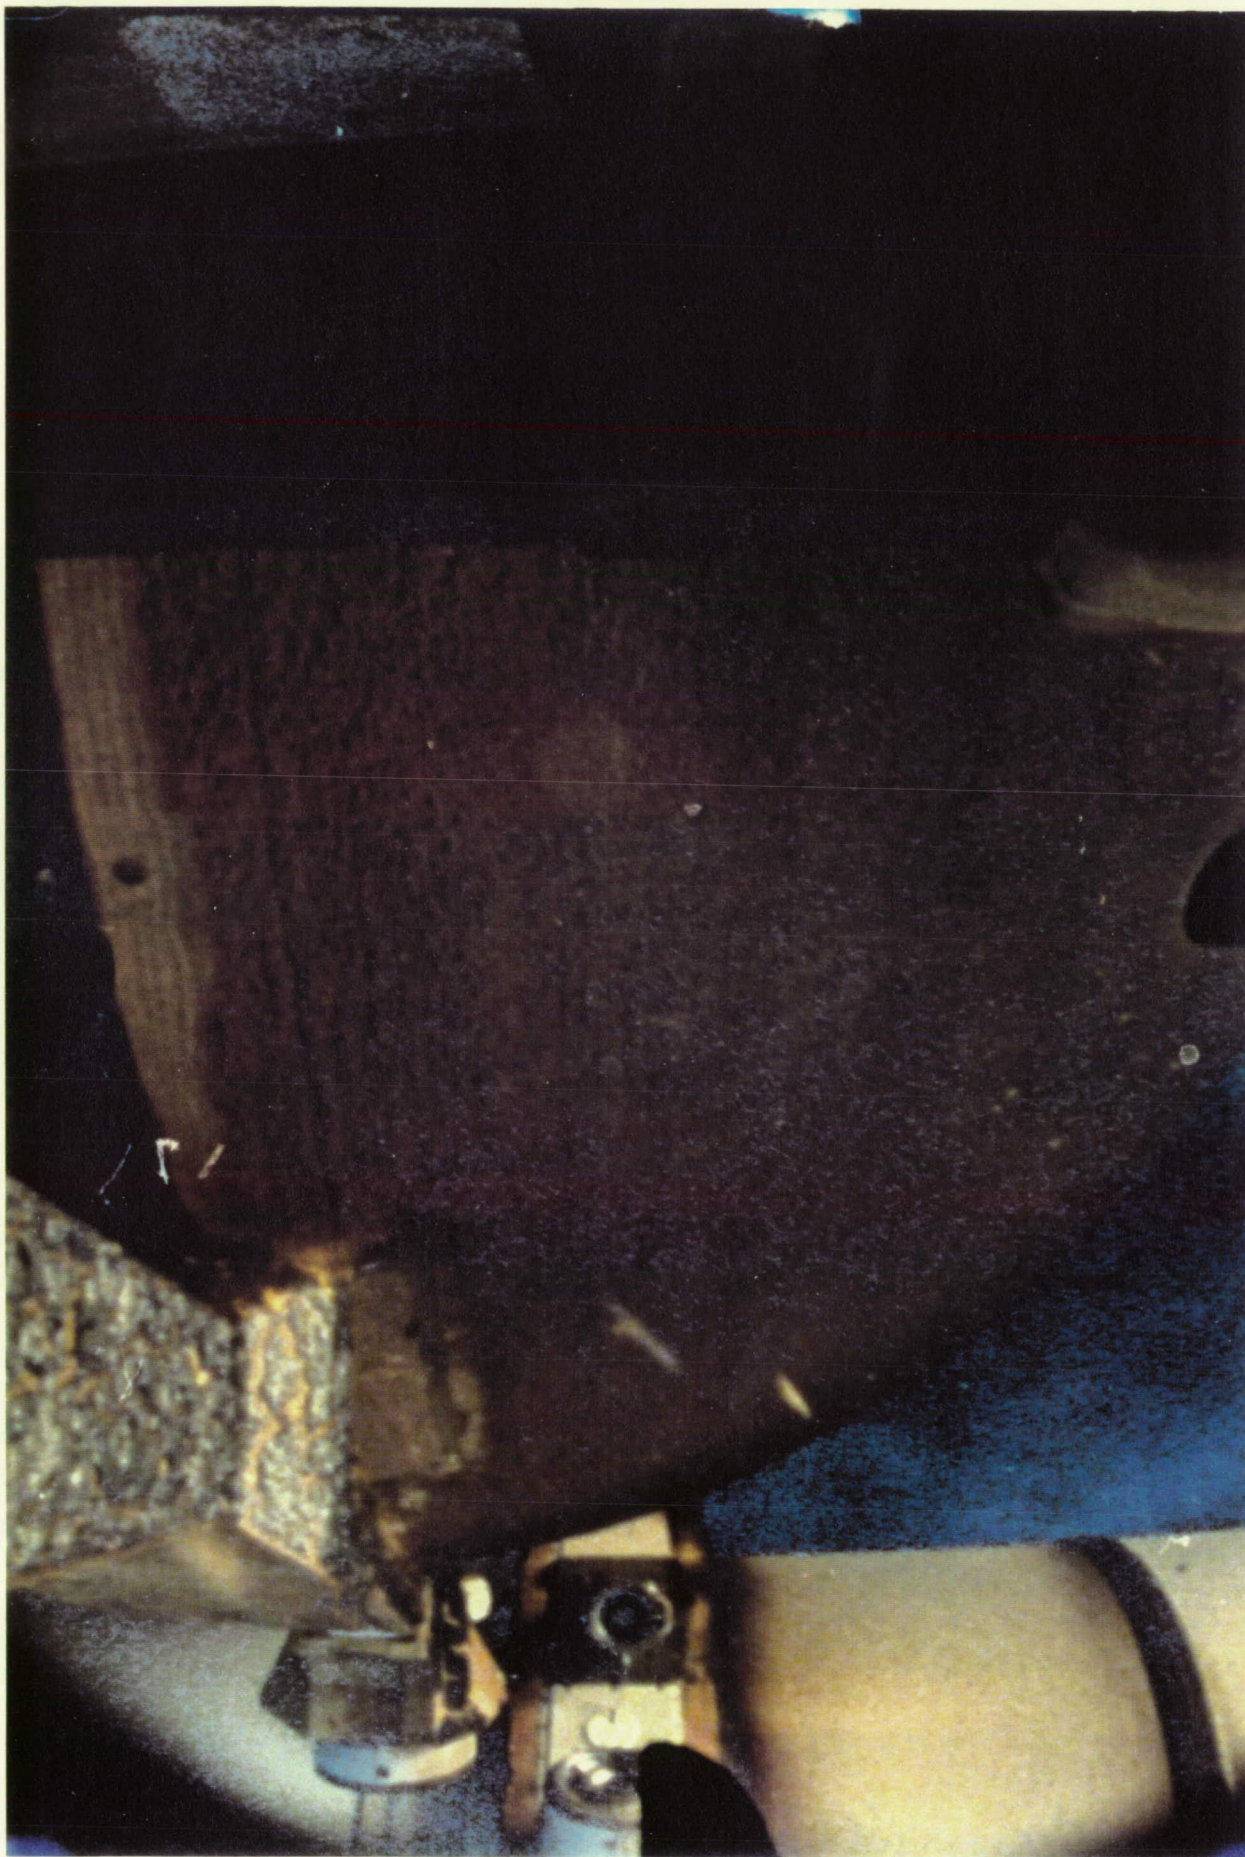
Wide angle view from a camera in the LH2 ET/ORB umbilical showed nominal separation of the LH SRB from the External Tank. Note erosion/loss of material from the TPS on the vertical strut/cable tray aft surface and the upper strut fairing.

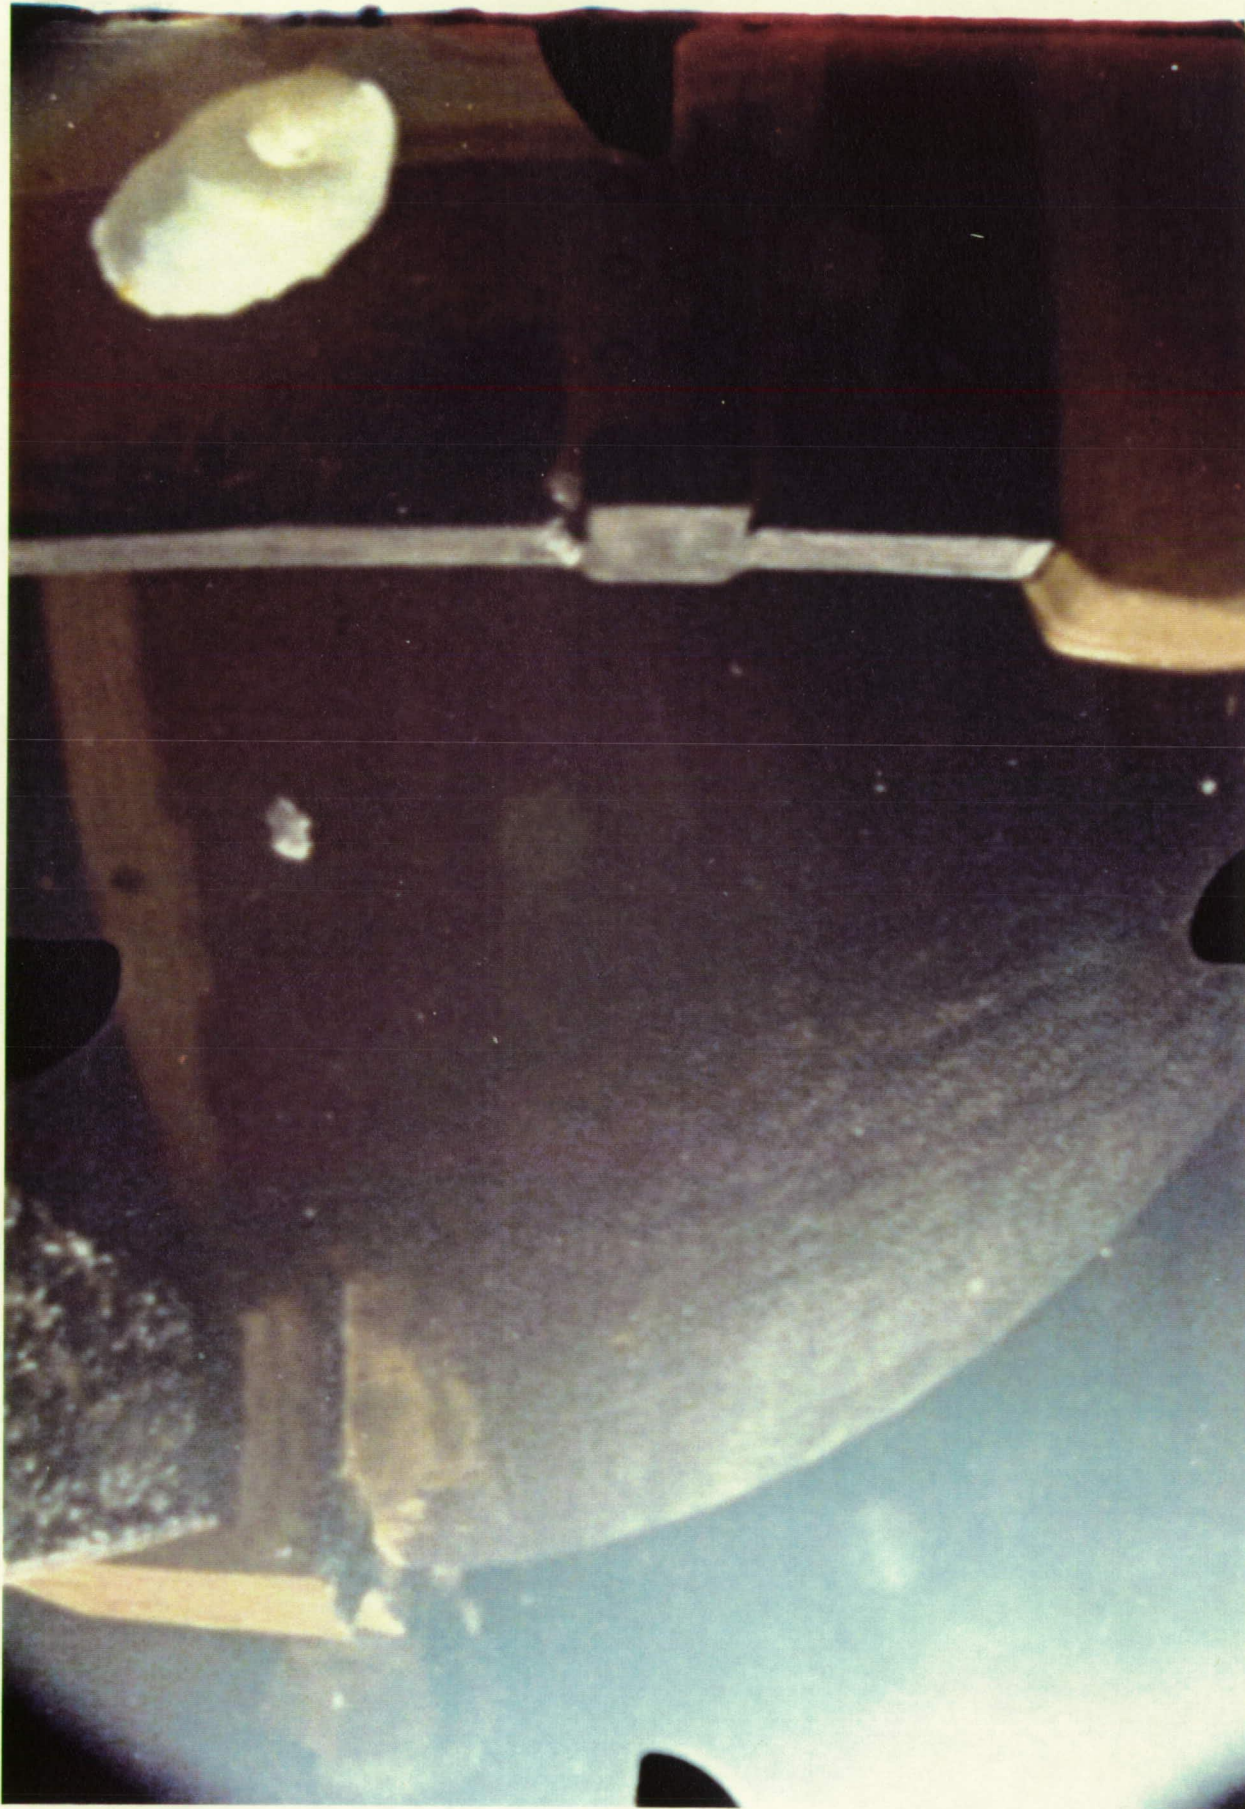
A white cylindrical rough-edged object drifted through the field of view and was most likely an ice finger from a forward purge vent tube inside the umbilical. Although not considered an anomaly, this type of ice formation had not been observed in umbilical separation films before.

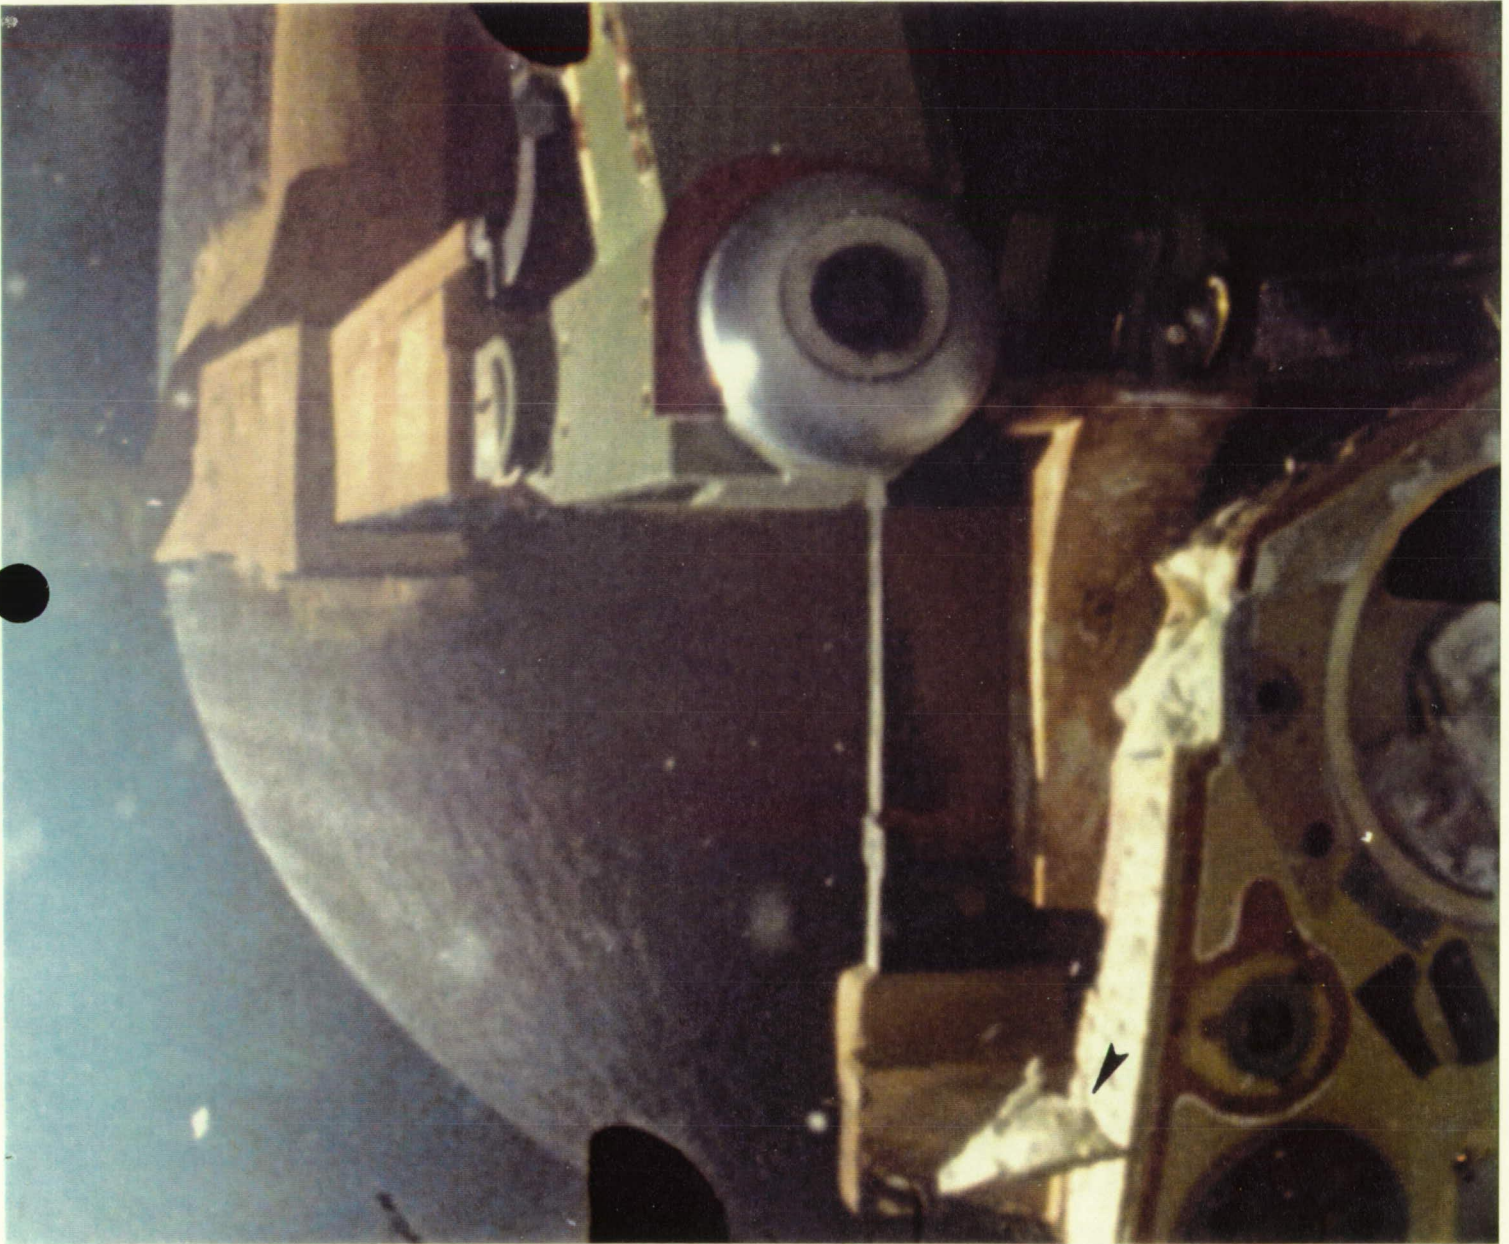
A small piece of foam with fire barrier material attached floated by the camera (arrow). It appeared to originate from the upper outboard side of the LH2 umbilical at the pyrotechnic canister closeout.

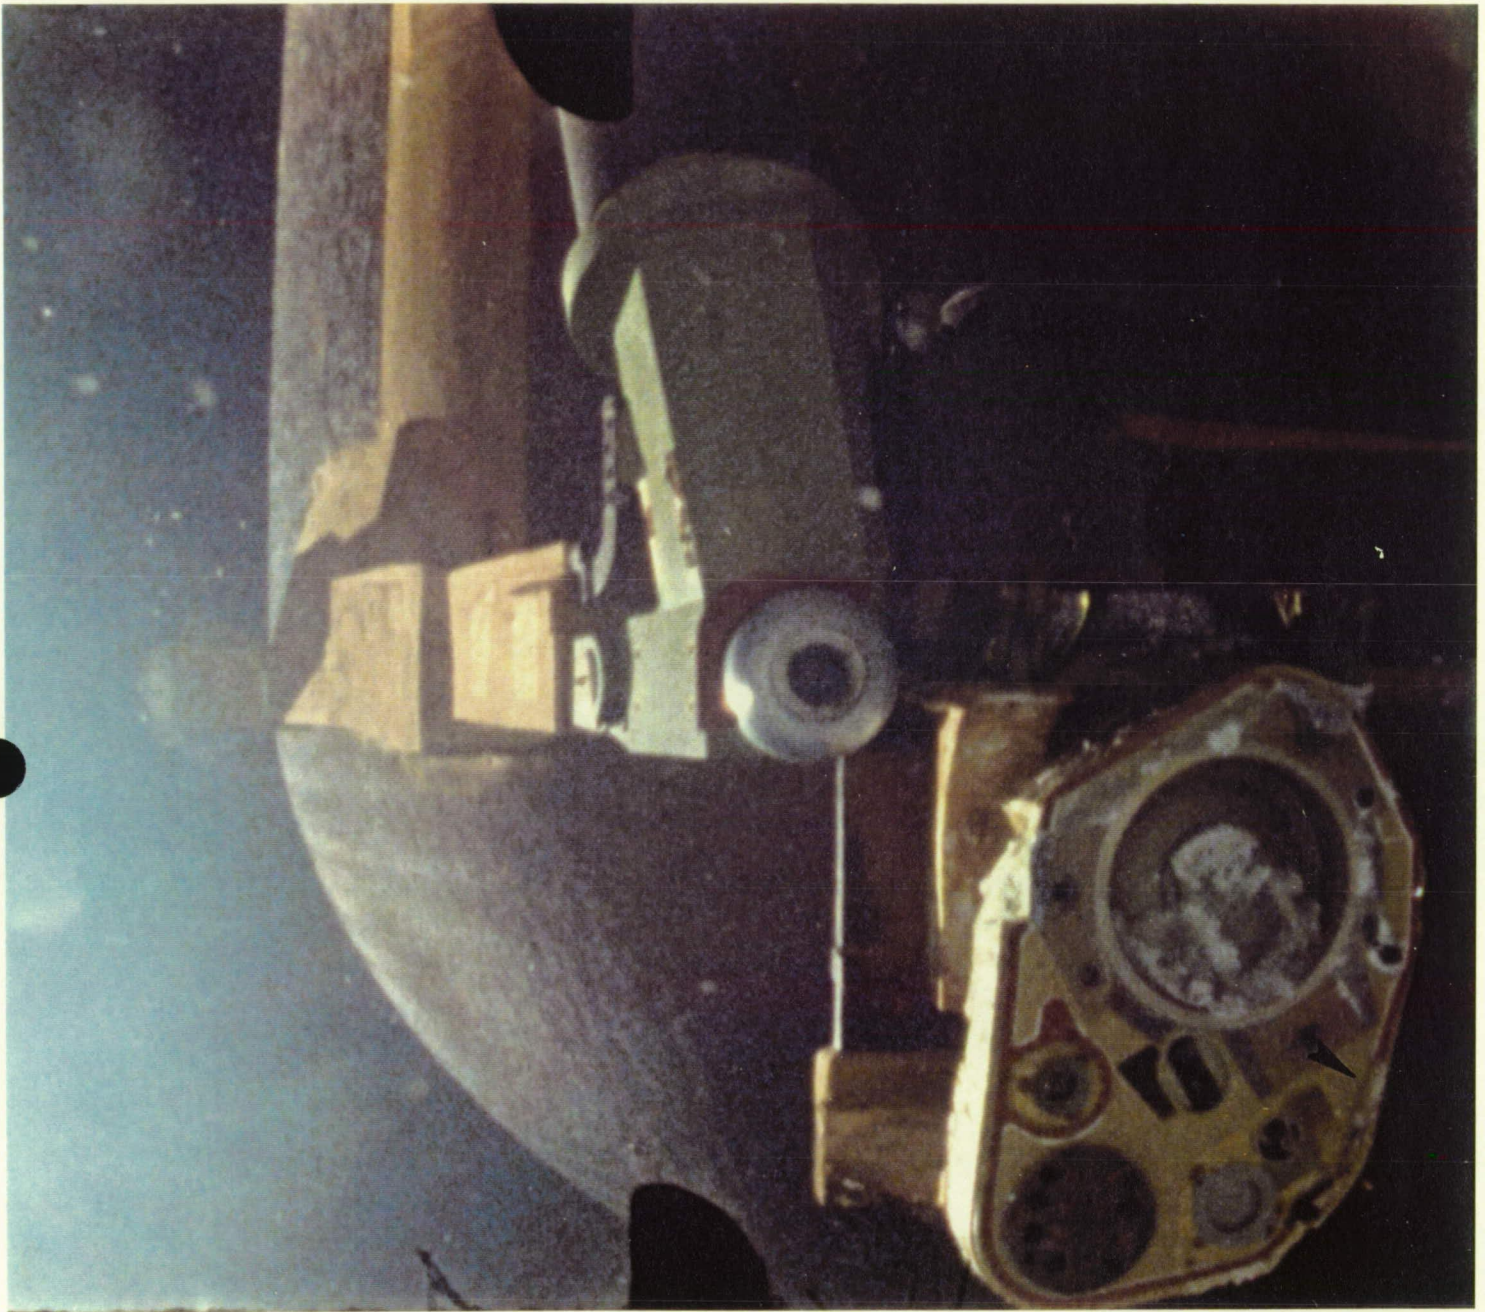
Structural separation of the LH2 ET/ORB umbilical appeared normal. Some TPS was lost from the upper outboard pyro canister closeout at separation. Rough appearance of the umbilical top and outboard sides was caused by blistering of the fire barrier material. A section of the red purge seal was missing from the aft inboard corner of the LH2 umbilical. This section of material adhered to the Orbiter side of the umbilical interface and was still attached after Orbiter landing.

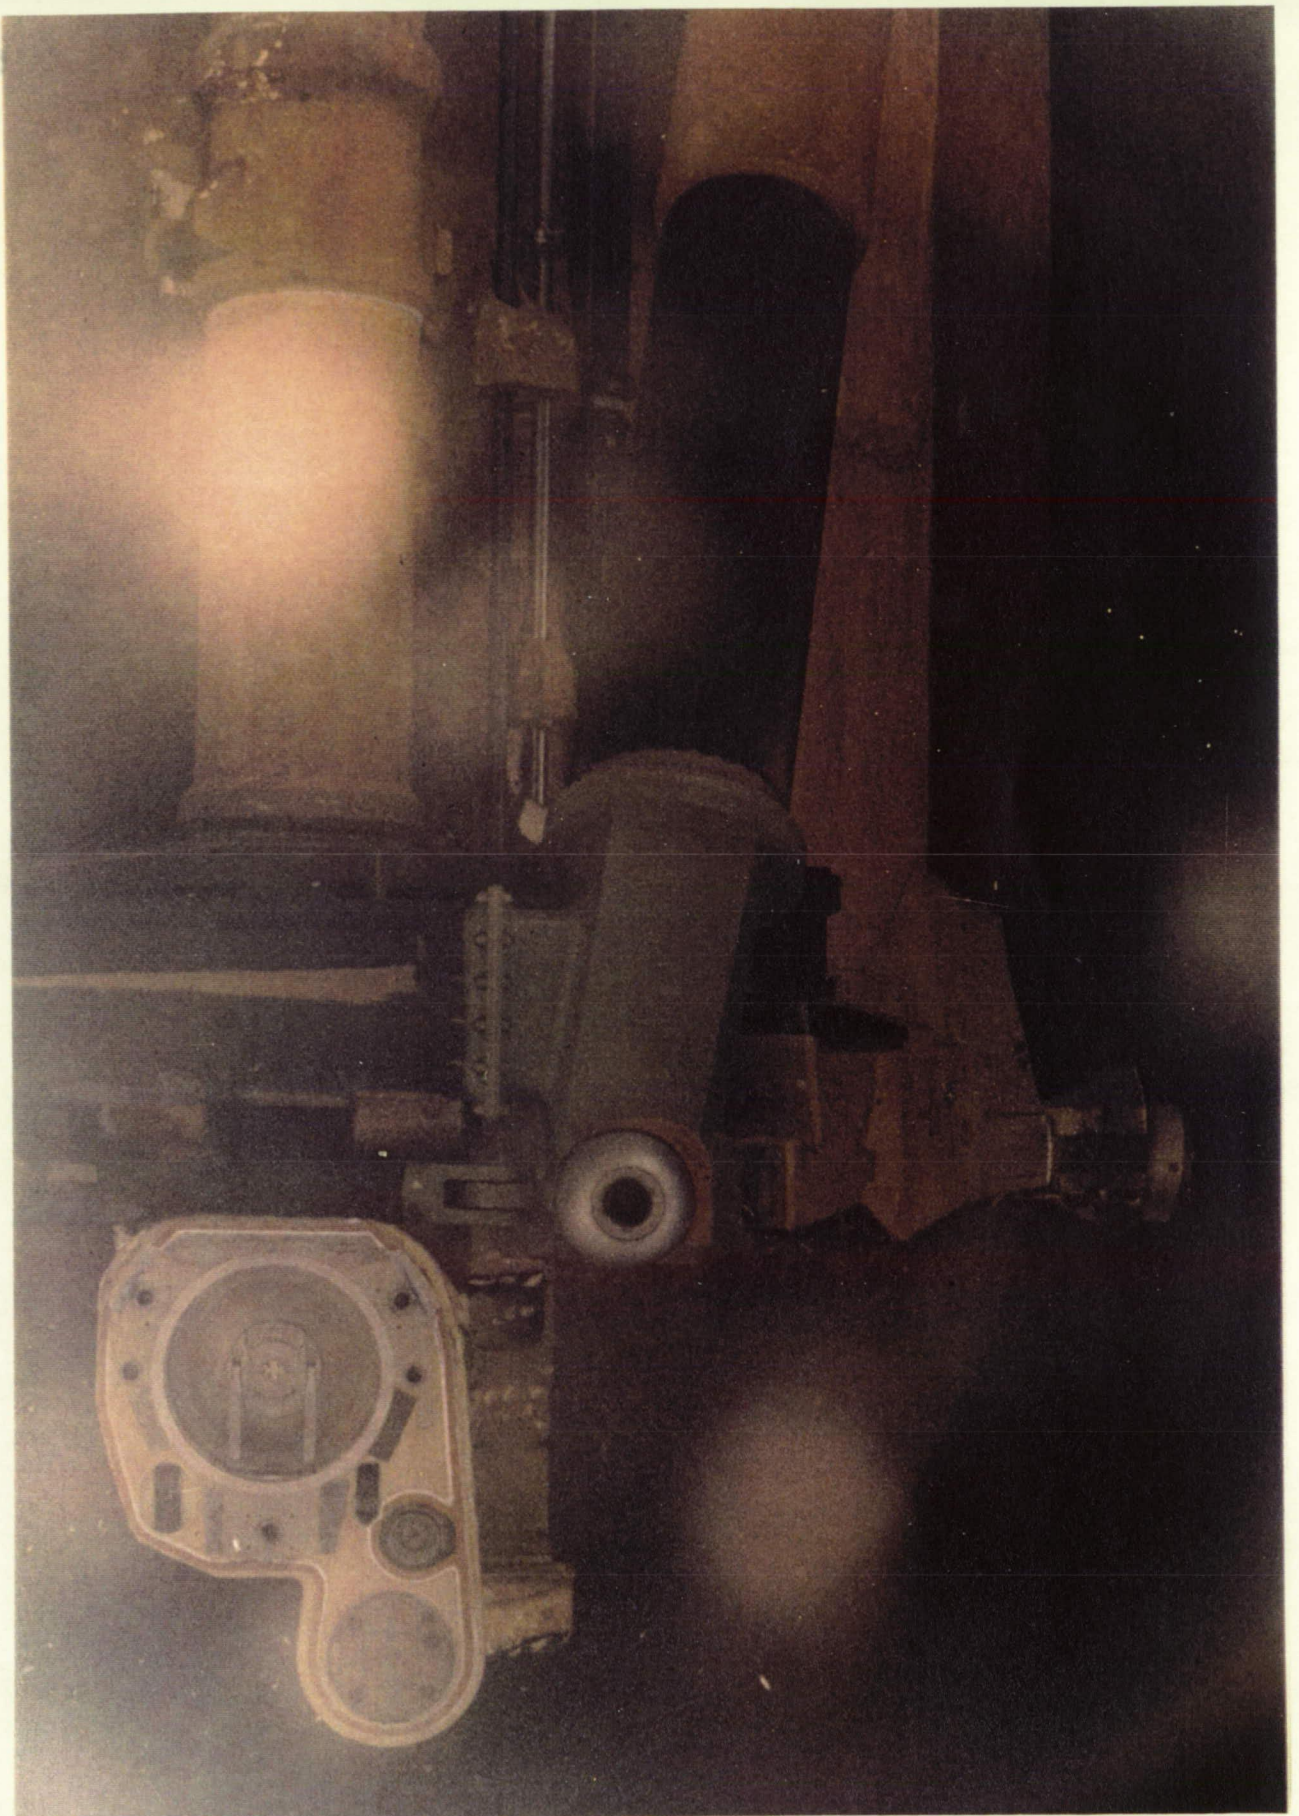
View from the LO2 ET/ORB umbilical separation camera showed possible TPS damage at the forward inboard corner of the LO2 umbilical. Pieces of TPS were missing from the vertical and horizontal sections of the umbilical cable tray.

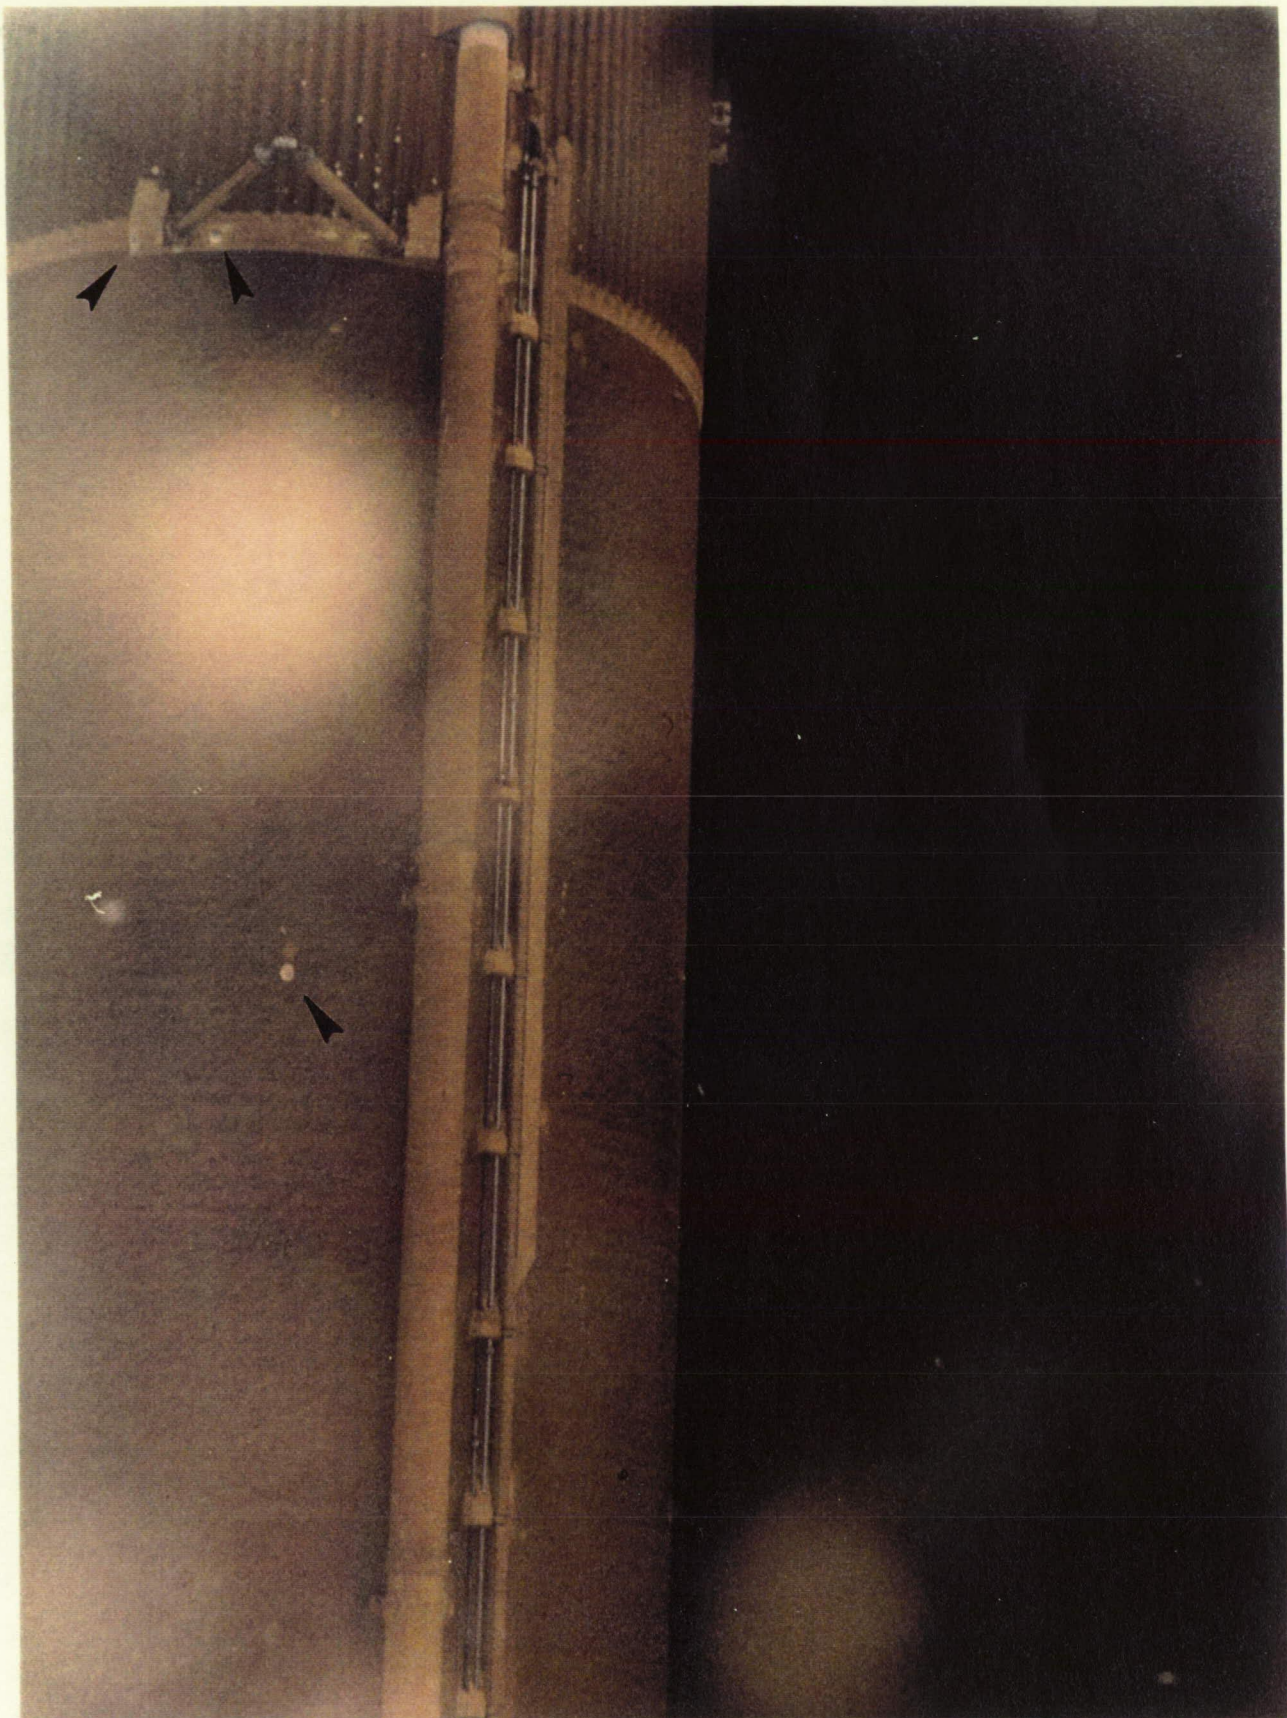
A 5-inch divot to substrate was present in the LH2 tank acreage at XT-1399 adjacent to a previously sanded area. Some of the left bipod jack pad closeout was missing. Foam was also missing from the aft outboard corner of the LH bipod ramp closeout.

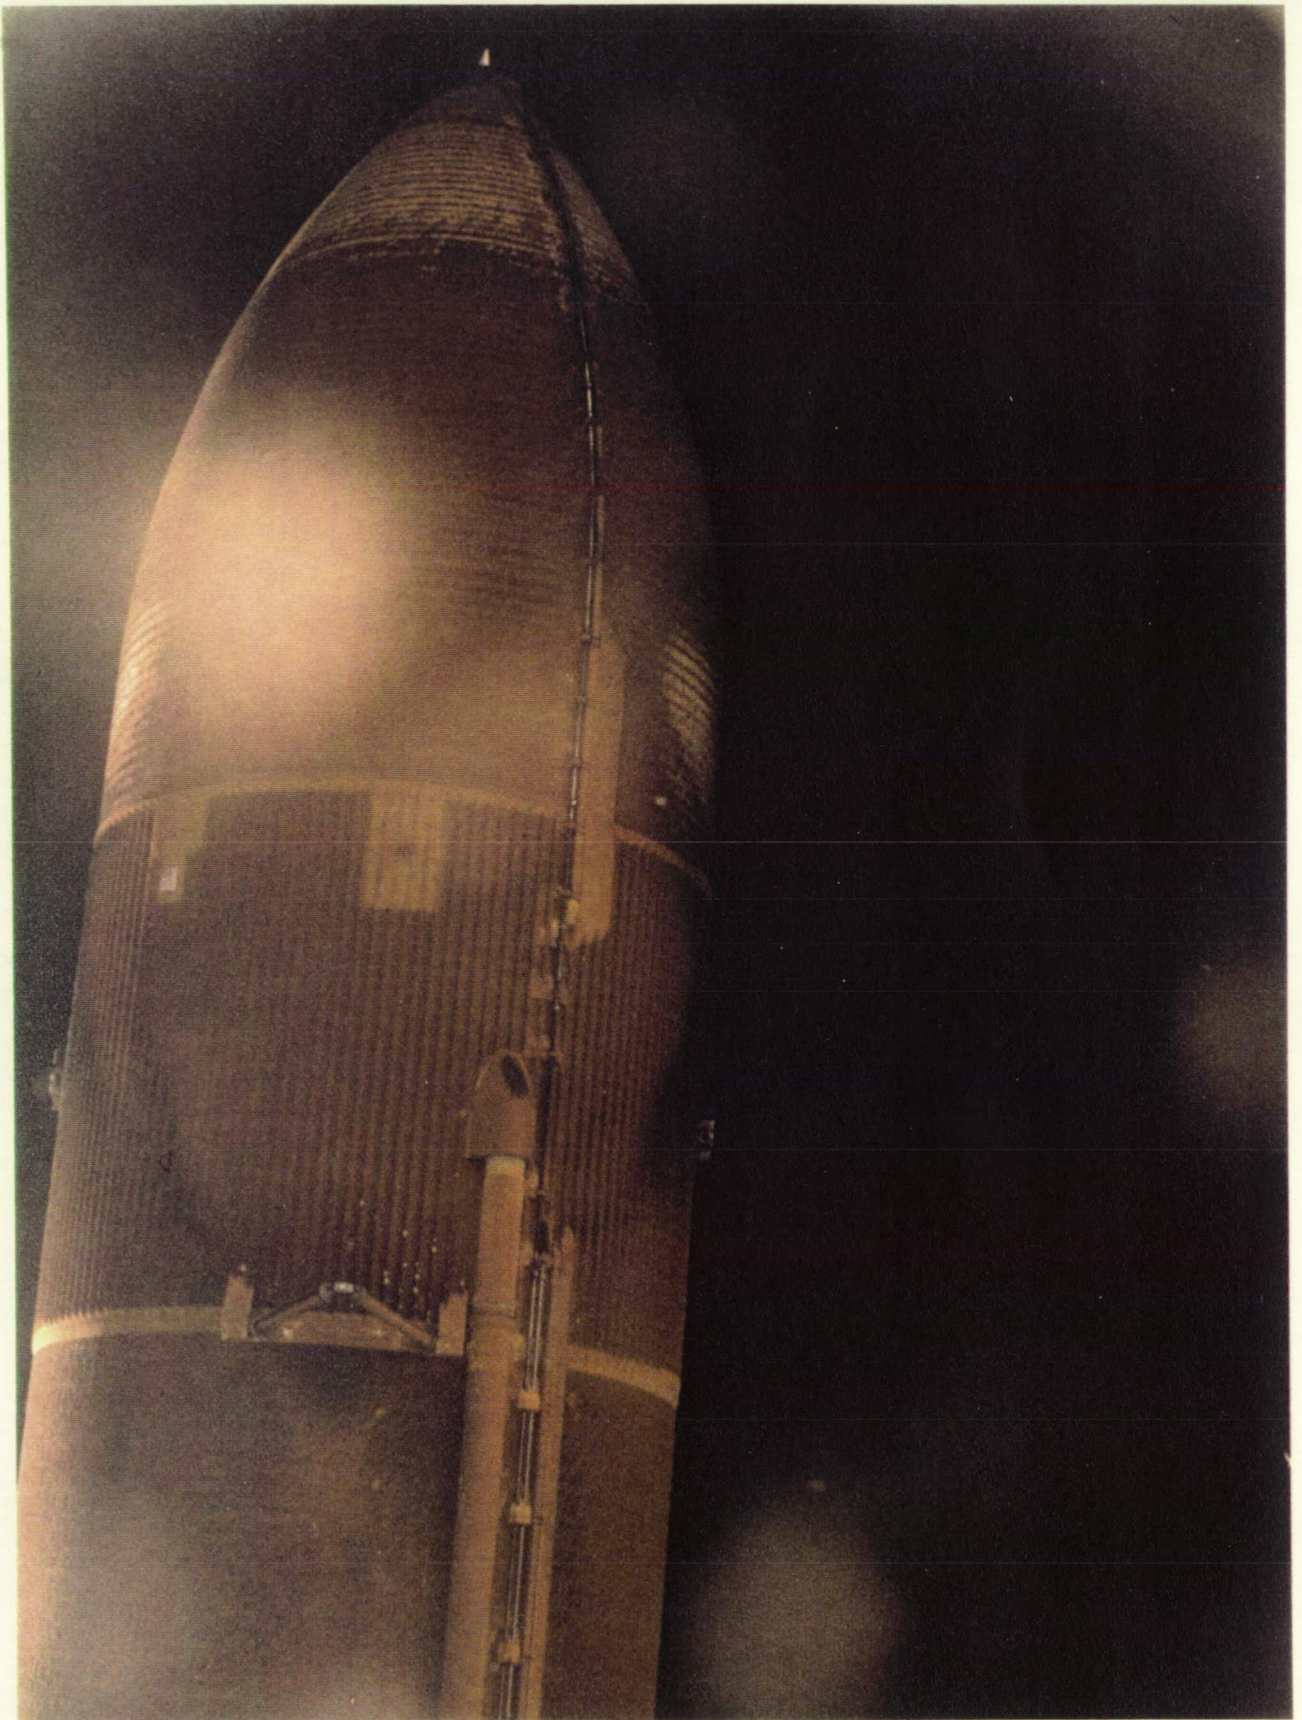
At least 20 small pieces of TPS were missing from intertank stringers forward of the LH2 tank-to-intertank flange/bipod area. No metal substrate or primer was visible. There were no divots in the flange closeout -Y+Z and +Y+Z quadrants. Post flight (ascent) condition of the LO2 tank/nosecone was nominal.

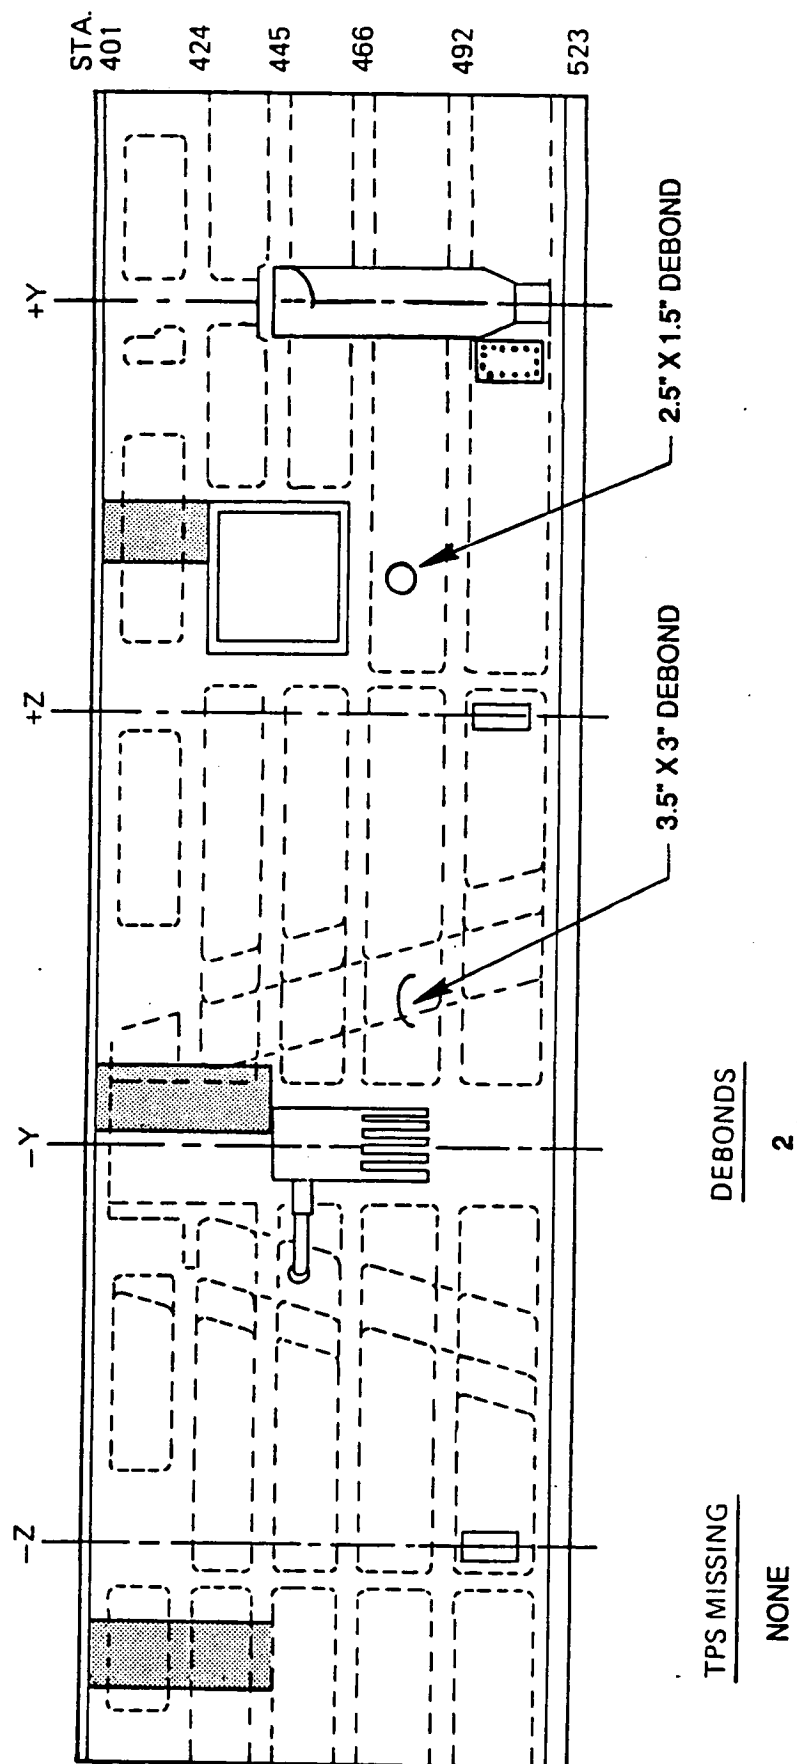
Figure 5. **RIGHT SRB FWD SKIRT**

MINOR BLISTERING OF HYPALON
PAINT AT ET/SRB FORWARD
ATTACH POINT

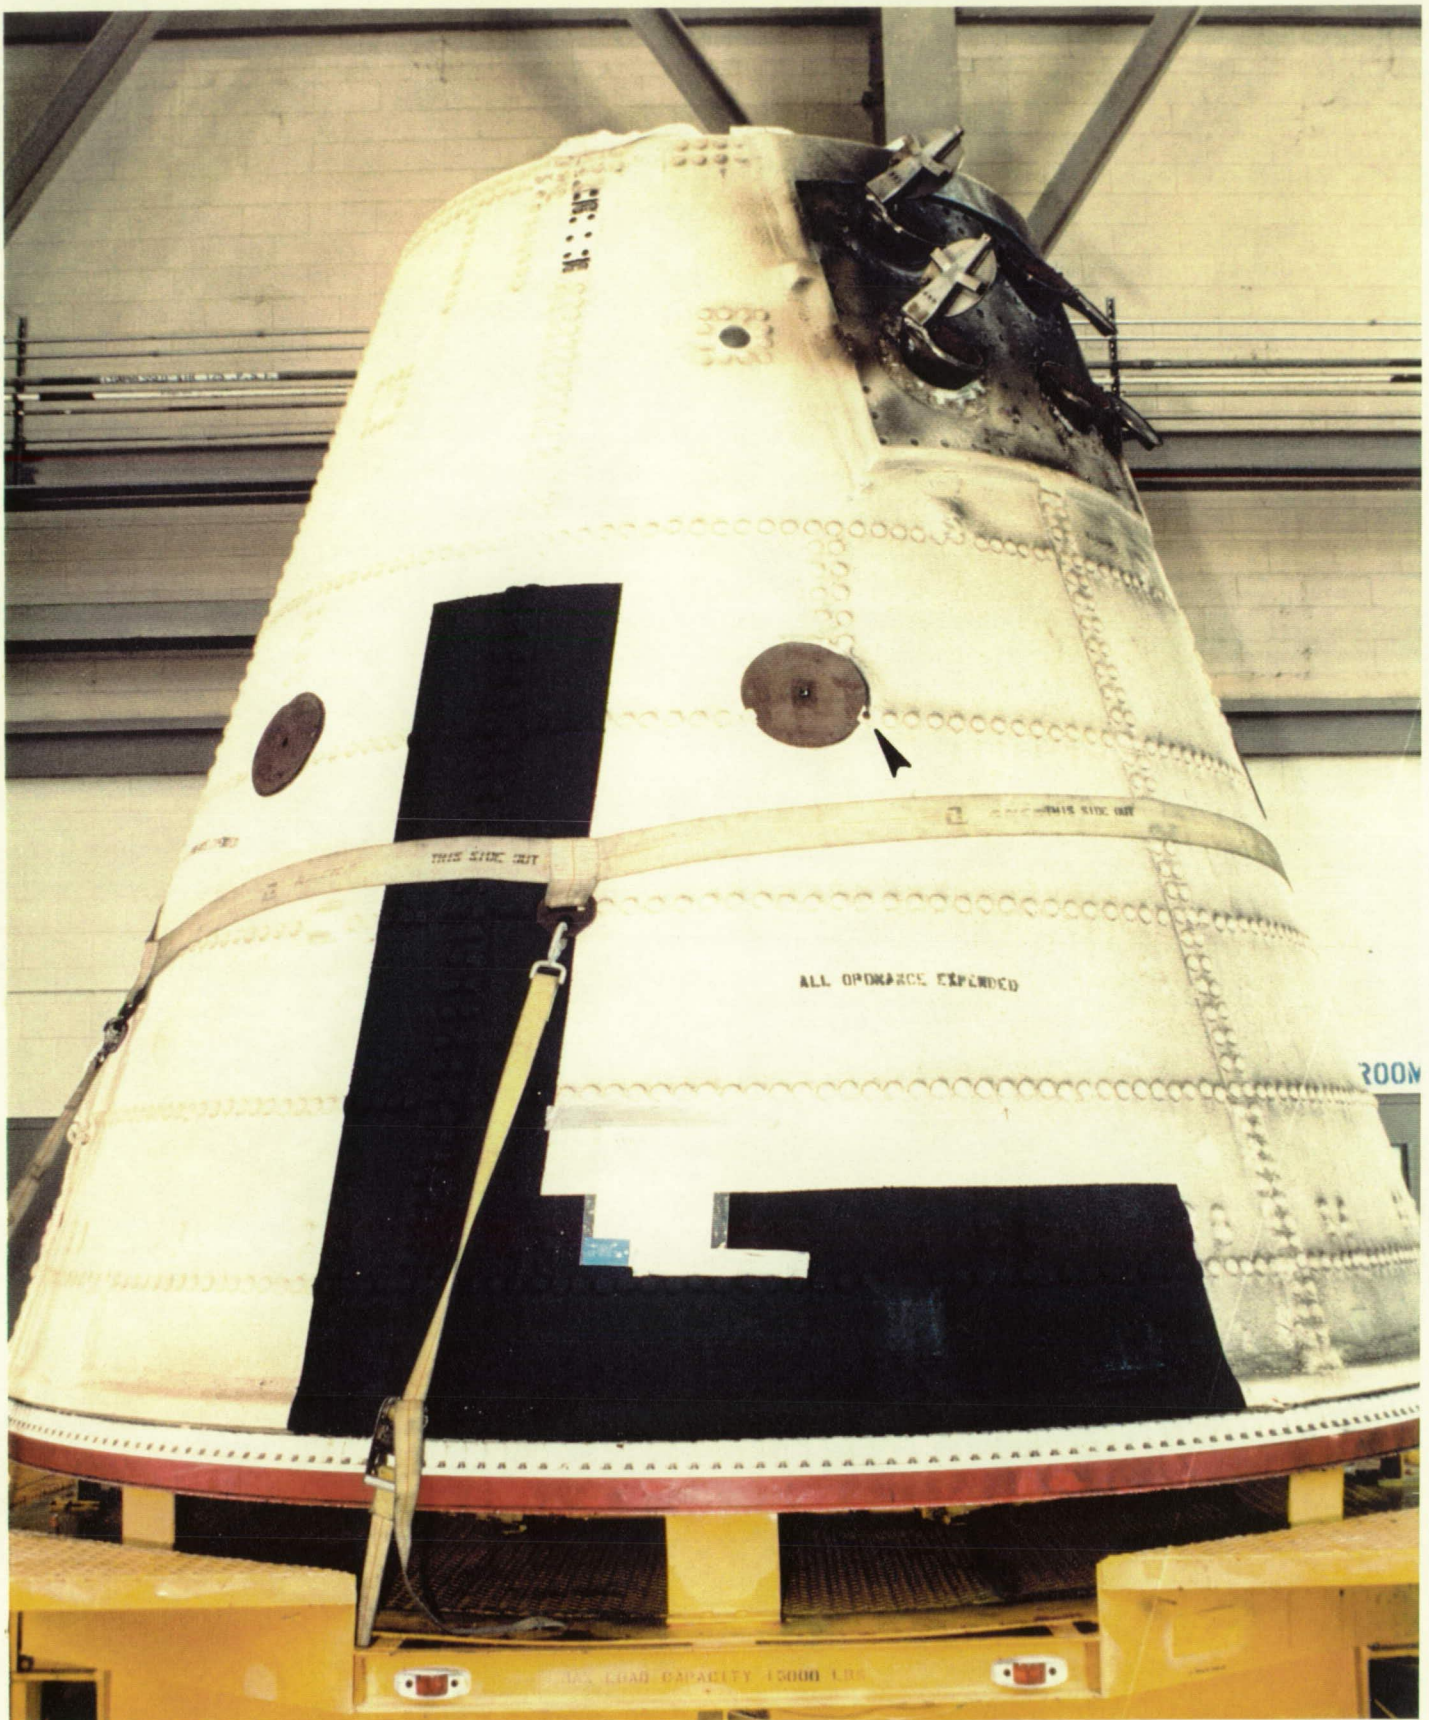
The RH frustum had 18 MSA-2 debonds over fasteners and one area of missing TPS near the pressure port (arrow). All BSM aero heat shield covers were locked in the fully opened position though the left two cover attach rings had been bent by parachute riser entanglement.
